**Test Report No: T1296-5**

**SAMPLE ID:** Genyk wall assembly containing Boreal Nature Elite medium density spray applied polyurethane foam insulation with steel face.

**TEST PROCEDURE:** Testing was conducted following the time temperature curve of CAN/ULC S101 to the following requirements:

- National Building Code of Canada 2015 (NBC), Article 3.2.3.8. Protection of Exterior Building Face, Sentence 2 CAN/ULC S101 15-Minute Stay In Place test.

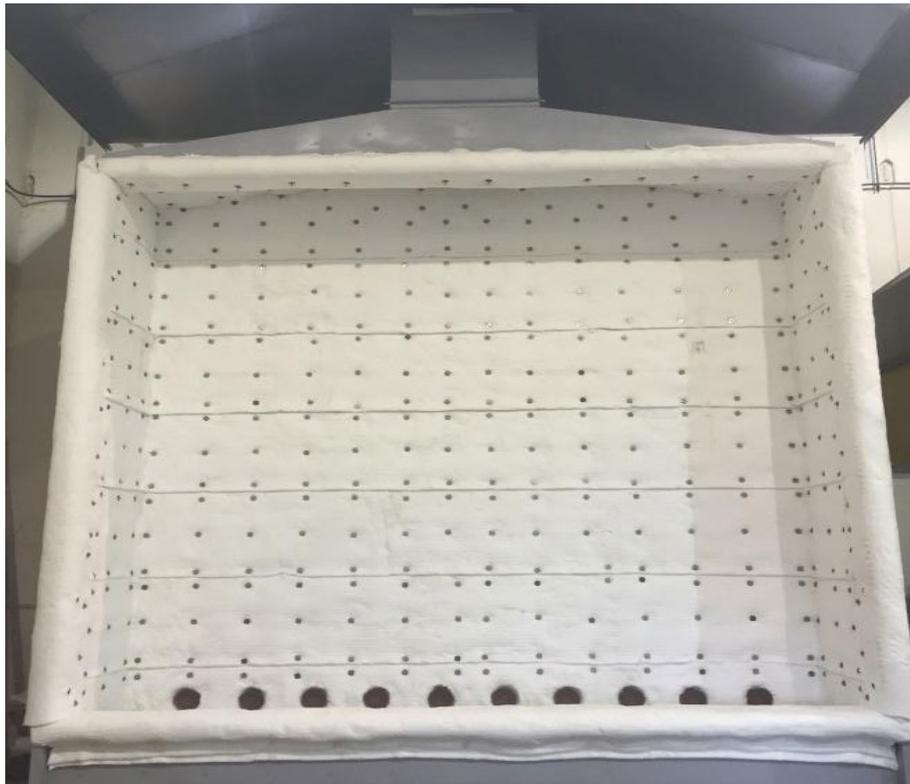
**Figure 1: Full Scale Furnace**

The furnace used in the test is a full-scale fire burning apparatus with interior dimensions of 3.96 m (13 ft.) in height, 3.96 m (13 ft.) in width, and 0.91 m (3 ft.) in depth.

Temperatures within the furnace were monitored using nine thermocouples (TCs). The temperatures are controlled by adjusting fuel to the furnace burners to conform to the time/temperature curve specified by the test standards. Temperature measurements are recorded by a Keithley 2750 data acquisition unit (ID# DMM1) which passes the readings to a computer for graphical display and storage.

The wall assembly was mounted in a vertical steel test frame. The test frame was then rolled up to the furnace and secured by chain and straps to the furnace opening. At the end of the test, the test frame was rolled away from the furnace so that the exposed face can be subjected to the impact, erosion and cooling effects of the hose stream test.

Two pressure taps are installed along the longitudinal center line of the test assembly. The pressure taps are each attached and monitored by Setra model 264 pressure transducers (ID# Pressure T1 and Pressure T2). The furnace pressure is controlled by adjusting a damper in the furnace exhaust stack. The furnace pressure was recorded continuously for the duration of the test.

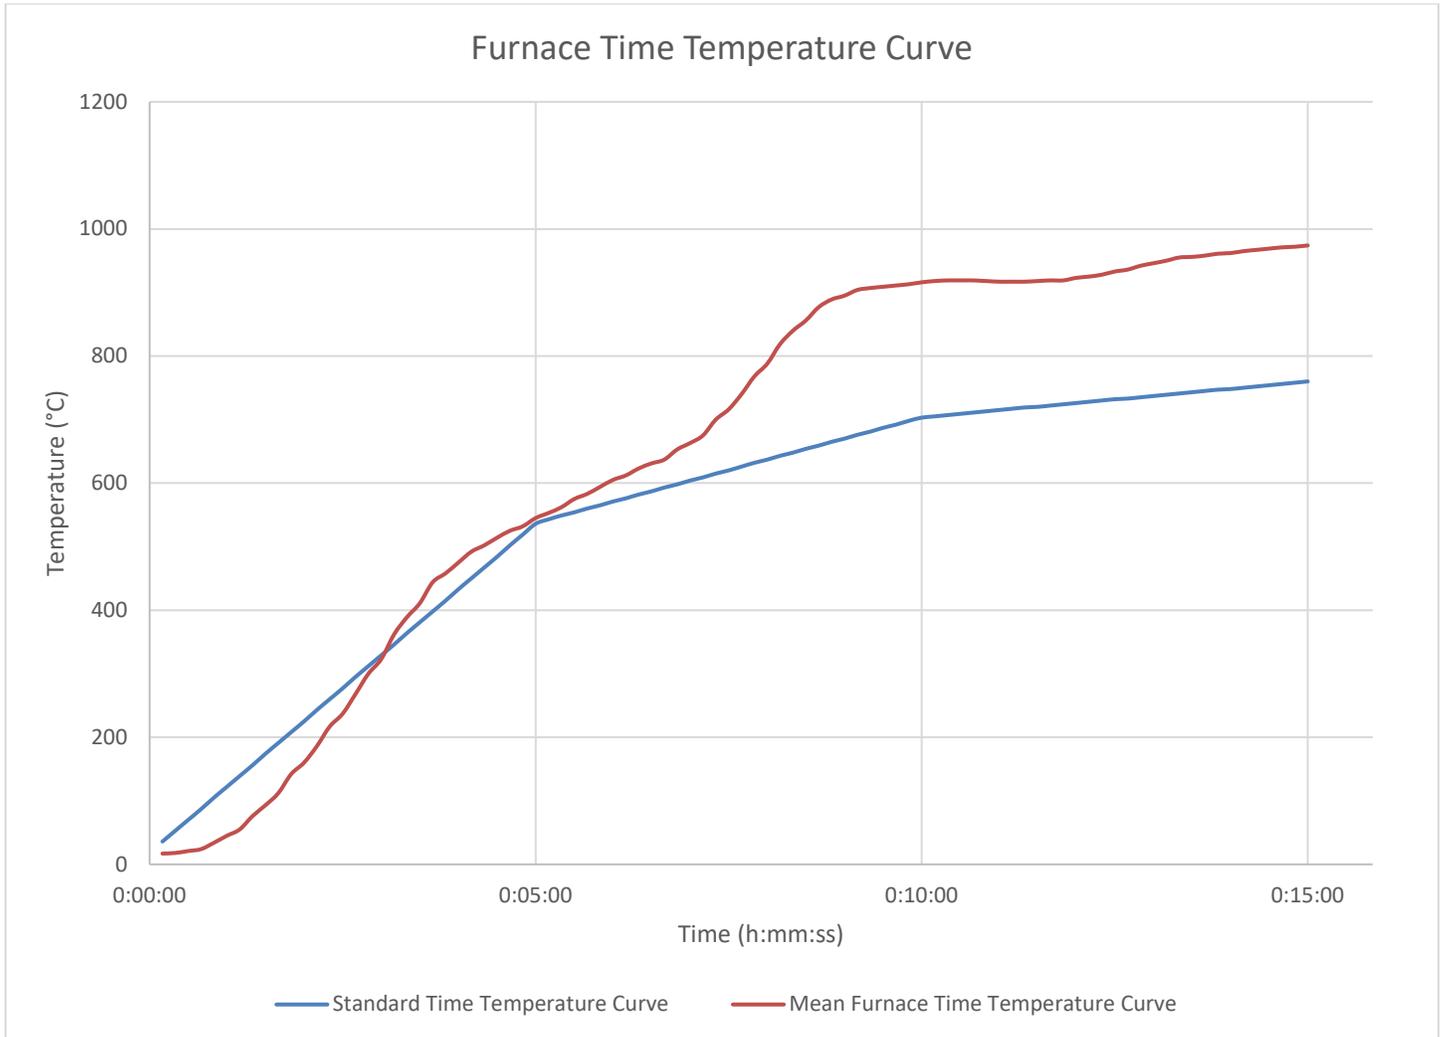
**Figure 2: Furnace Time Temperature Curve**

Prior to the fire endurance test the test assembly was moved into position in front of the furnace and the pilot burners were ignited. The fire endurance test was initiated after igniting the burners. The temperature inside the furnace was controlled to follow the standard time/temperature curve within the limits described in CAN/ULC S101.

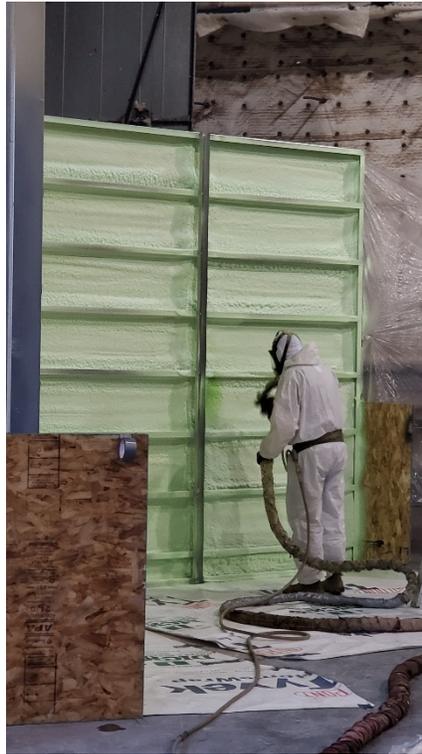
**Figure 3:** The exposed face during spray foam application.

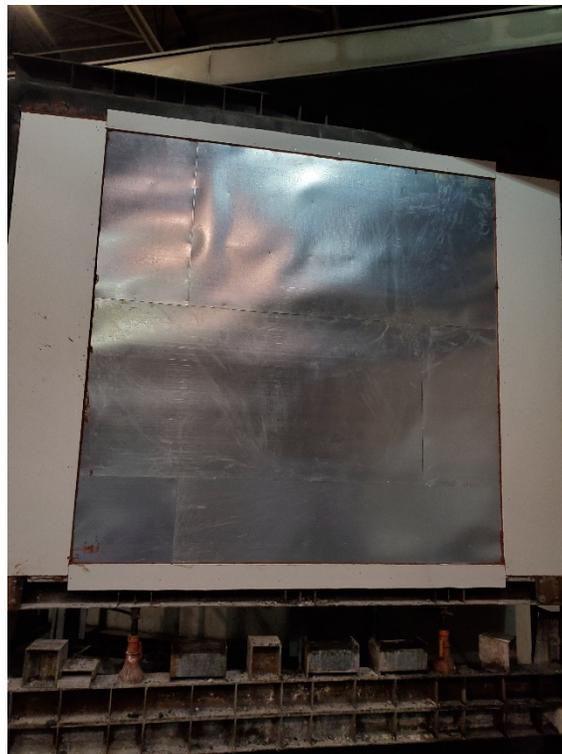
**Figure 4:** The exposed face prior to the fire test.

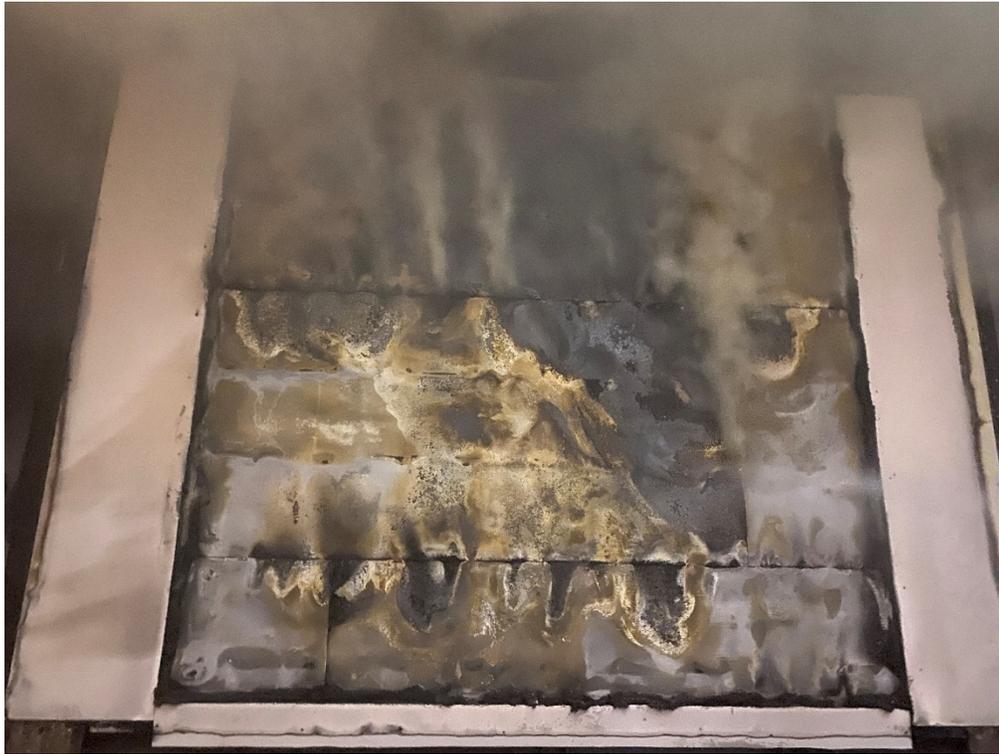
**Figure 5:** The exposed face after extinguishing the flames.

After the wall was rolled away from the furnace it was observed that there were no openings in the steel face when viewed normal to the face.

The steel sheet remained in place for the duration of the test. There were no through openings through to the spray foam insulation. The protective barrier did not deteriorate in a manner that flame could propagate along the panel surface.
