10998.000
Genyk Spray Foam Adhesion
Testing

REGARDING **Adhesion Testing Results**

As requested by Genyk Polyurethane Solution (Genyk), RDH Building Science Laboratories (RDH) is pleased to provide you with this report regarding adhesion testing of Genyk 'Boreal' 2.0 pcf closed cell spray foam (CCMC#14025-L).

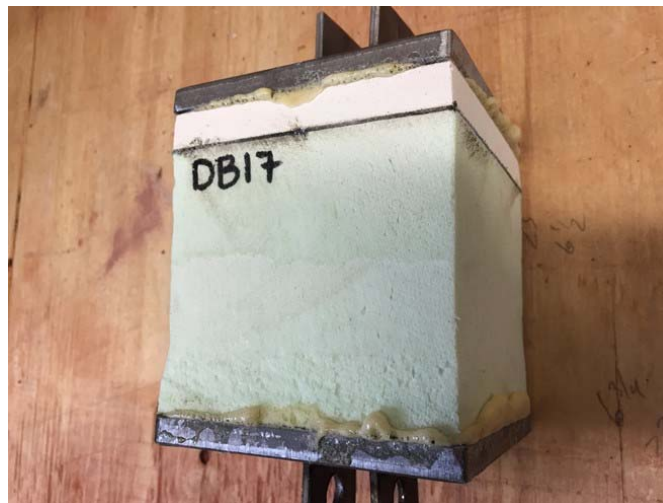
Figure 1 : Prepared Foam sample installed on Blueskin SA for testing

Testing was completed in substantial compliance with ASTM D1623-03 (Standard Test Method for Tensile and Tensile Adhesion Properties of Rigid Cellular Plastics) for a Type C specimen. Samples 4" by 4" (16 sq. inches) in surface area and 4" in total thickness (including DensGlass sheathing) were chosen. A photograph of a sample is shown in Figure 1. The objective of the test was to demonstrate that the adhesion of the spray foam to the substrate (DensGlass or Blueskin SA in this case) exceeded the Air Barrier Association of America (ABAA) adhesion requirement for an air barrier material on a substrate of 16 psi (110kPa). For the 4"x4" sample size chosen, a load of 256 lbs was the minimum target.
