December 13, 2020
Technical Bulletin #402

Subject: Radon Control Layers for Retrofit Applications
Closed-Cell Spray Polyurethane Foam: Better, Faster, Less Expensive

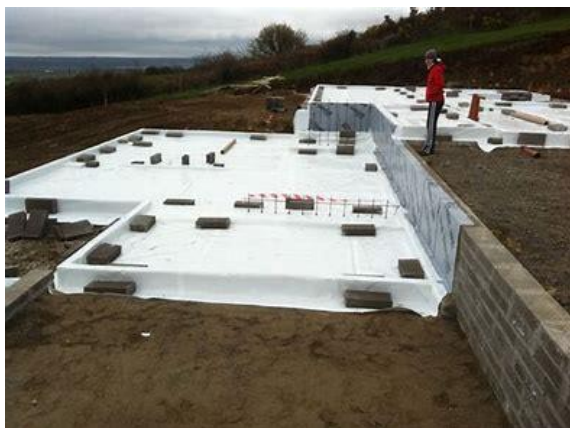
New construction membrane installation

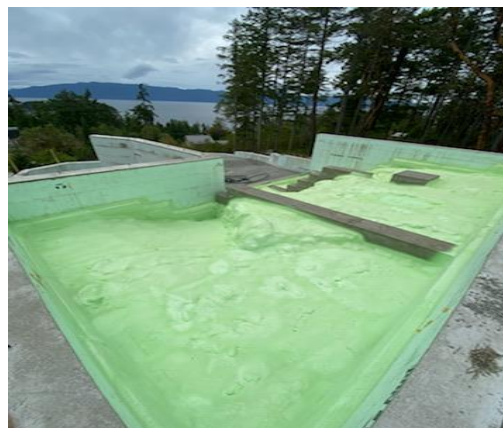
New construction Boreal Elite installation

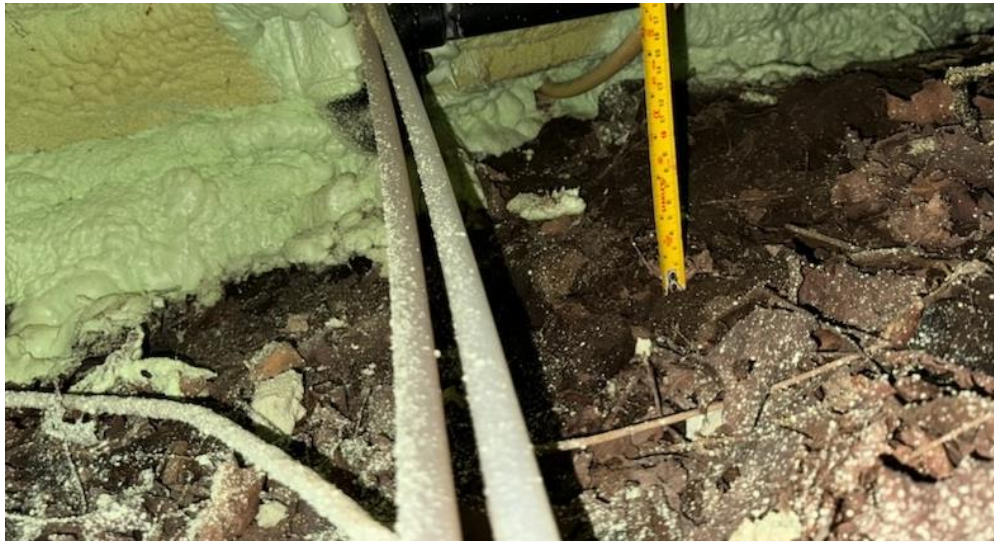
Areas of limited clearance – wall/floor junction less than eighteen inches

The crawl space tested was selected because of the existence of several accessibility issues. The North/South slope ranged from eighteen inches at the North elevation to seventy-two inches of clearance at the South elevation. The span (from exterior wall to areas greater than eighteen inches) ranged between twenty-four and thirty-six inches. Obviously, the adhesion of membranes to the exterior walls in these areas would, at best, be labour intensive. At worst, gaps where the membrane was not correctly installed would allow radon gases to enter the crawl space.

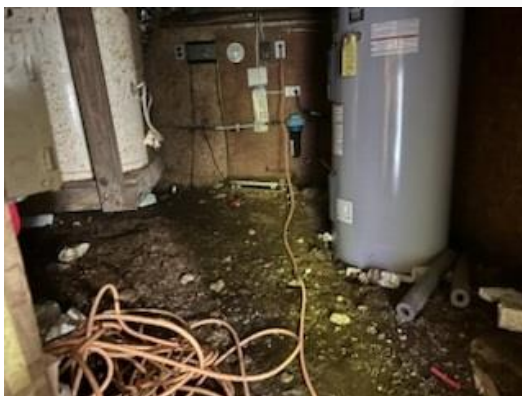
BEFORE - Clearance issues below water tanks

Further, ensuring continuity of the radon control layer on the floor would be left to probability rather than certainty because of the inability to visually confirm the application. Similarly, the solution to providing a monolithic control layer under appliances was only possible with the 'bulk-fill' ability of ccSPF. The water heaters in the case study had clearances of ten inches and 3 inches respectively.

(the furnace was six inches, not shown). Installing membranes to these areas without removal would be impossible. But with ccSPF, the process was not only attainable but was done so quickly and with certainty.

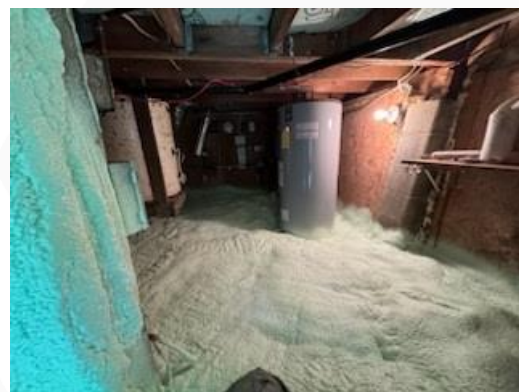
AFTER – Complete seal under appliances

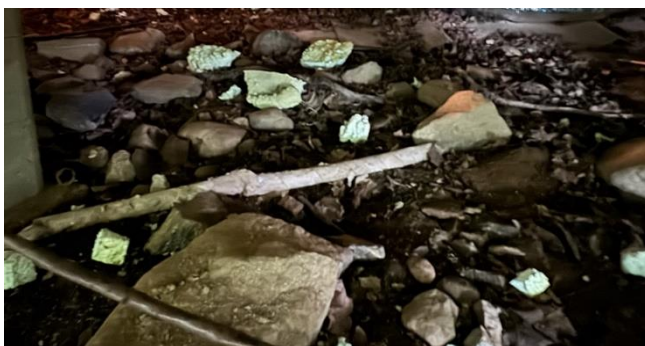
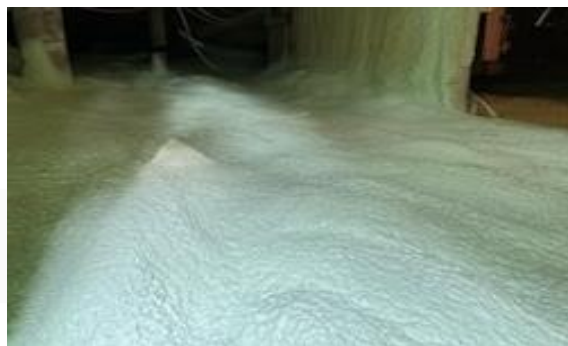
Before/After - ccSPF installed over rocks and root systems

Boreal Elite ccSPF is a permanent control layer. The spray foam is installed under, around and on top of irregular surfaces. Rocks and roots are embedded in the spray foam, and thus, are prevented from puncturing the control layer. ccSPF has excellent adhesion to auxiliary substrates like wood, steel, ABS and rock. This adhesion allows for a monolithic application. Because the installation is free of mechanical fasteners, sealants and secondary detail materials that typically fail over time, the *Boreal Elite* radon solution is permanent.

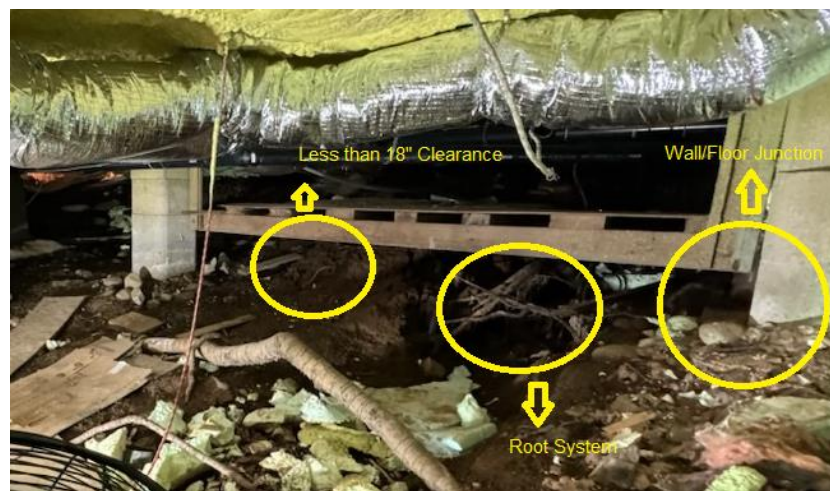
BEFORE – Clearance, protrusions and unreachable wall/floor junction

Even self-adhesive membranes require mechanically fastening at the wall/floor junction. However, when clearance is limited to eighteen inches or less, and the span of reach is greater than twenty-four inches, succeeding with a proper installation of membrane is virtually impossible. There will be gaps if the self-adhesive is not complete. Similarly, if the fastening bar is not properly affixed to

the wall junction, gaps and penetrations will be present. Obviously, the entire purpose of a radon control layer is continuity. Even the smallest penetration will allow radon to penetrate the assembly. Fastening bars are prone to wear. Especially if not installed correctly. Given access limitations, the mechanical seal that is necessary to ensure the continuity of membranes is often not possible. At a minimum, the fasteners will not be installed to specification. An incomplete, or improper installation facilitates future breakdown. Any and all gaps in a radon control layer result in access of the gas into the living space.

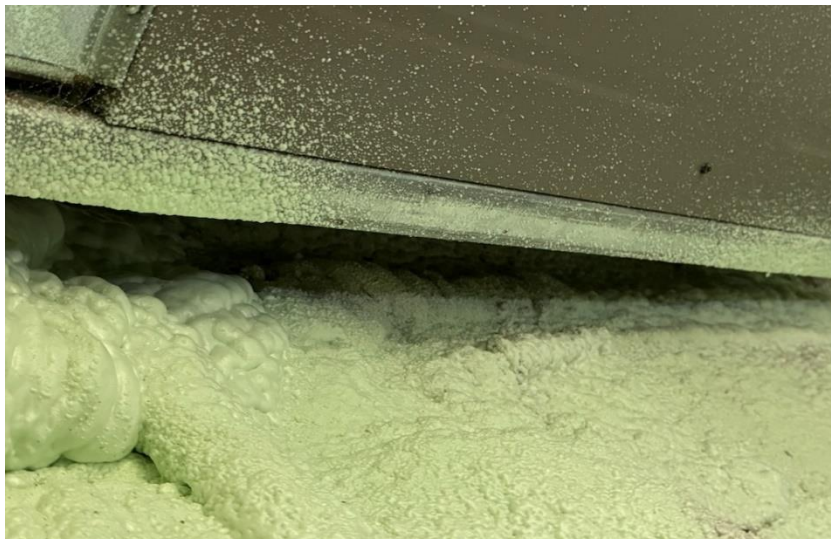
AFTER – complete seal with Boreal Elite ccSPF

Boreal Elite ccSPF solves both the floor / wall junction and the continuity of the radon control layer with relative ease. Spray foam can be sprayed thirty-six inches away from the substrate. Not only can the wall be completely sealed, because the floor level control layer is installed from the wall towards the sprayer – all applications can be visually observed during installation.
